# Safety Inspection Report

Annual Inspection

## Church Lane

02 August 2022

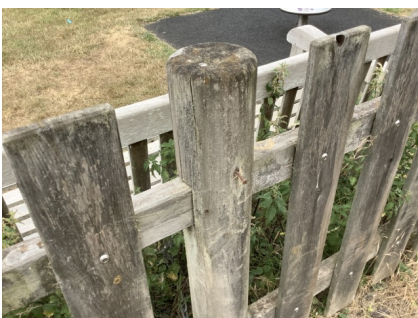
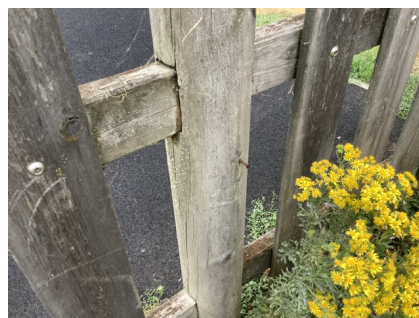
Hard or sharp projections.

Remove protruding nails.

Remove hard, pointed and sharp projections.

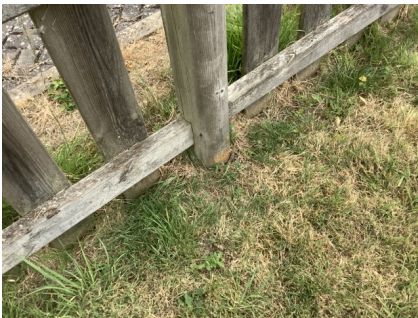
Strimmer damage to supports is likely to accelerate timber rot.

Prevent further damage.

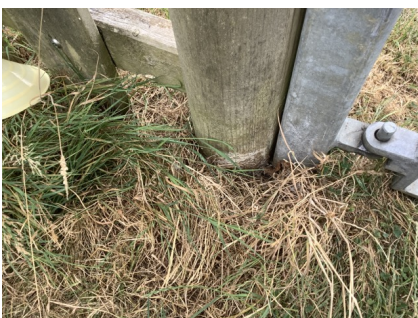
Timber is decayed.

A number of fence posts are softening at ground level - monitor.

Check on a routine basis.

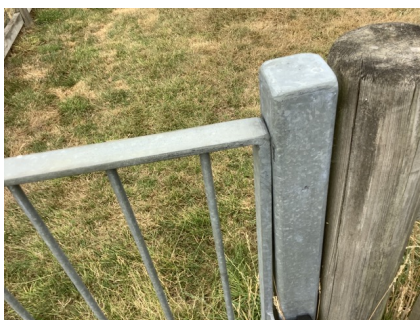
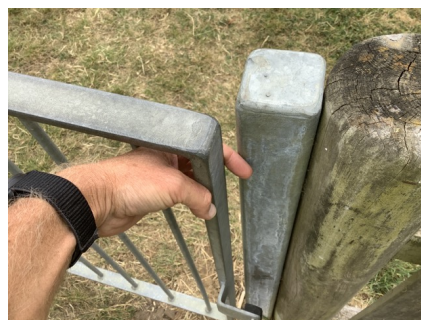
Entrapment on side(s) of the gate.

Adjust gate / posts / fit new rubber buffer to ensure a spacing of at least 12 mm throughout the range of the gate to remove the entrapment. The 12 mm gap also should apply on the hinge side of the gate.

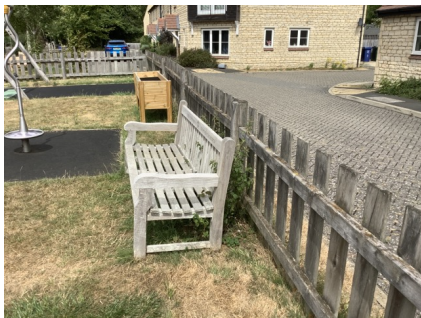
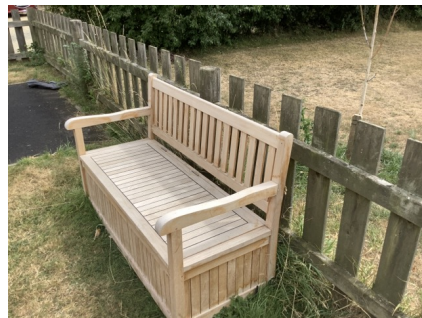
RoSPA recommend a minimum distance of 1 m between seat and fence. This is to reduce the likelihood of children vaulting the fence via the seat.

No reasonably practicable action is identified.

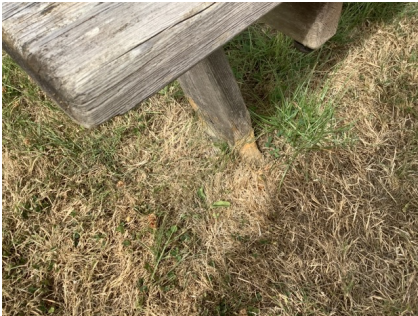
Strimmer damage to supports is likely to accelerate timber rot.

Prevent further damage.

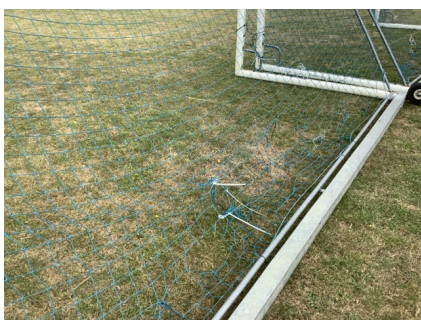
Item is damaged.

Repair or replace damaged net.

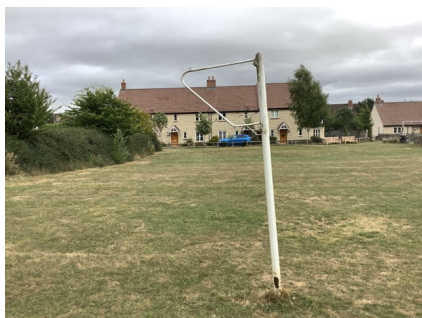
Loose in ground.

Reset.

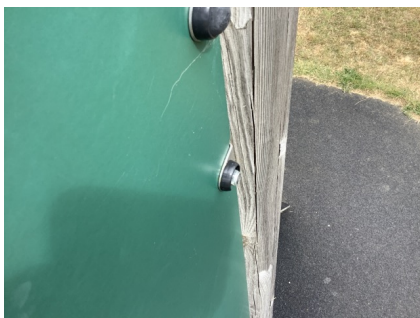
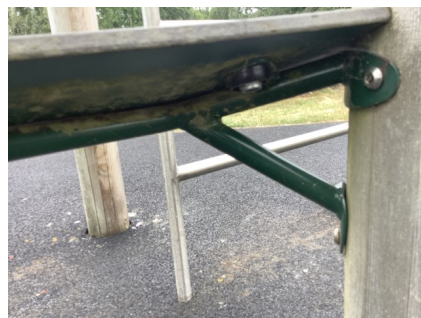
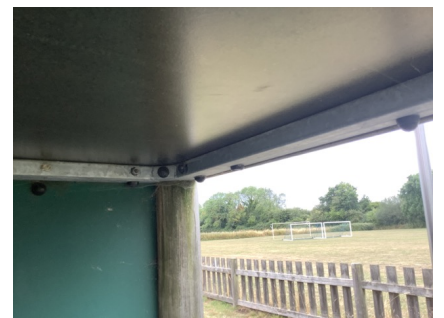
Cap missing.

Replace.

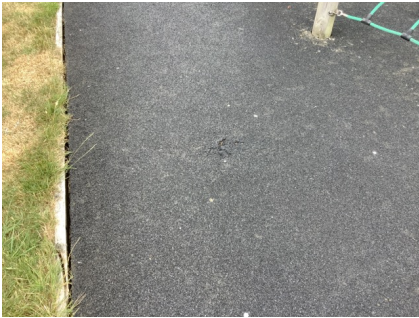
The wet pour surface is cracking.

Repair.

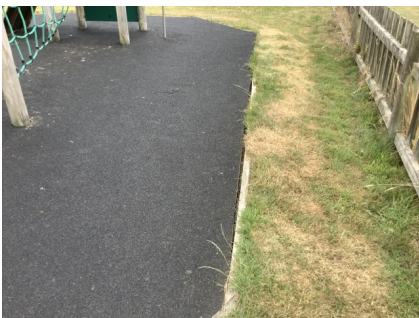
Shrinkage / separation of the surface. This may give a trip hazard.

Re-glue and fill gaps and joints as necessary.

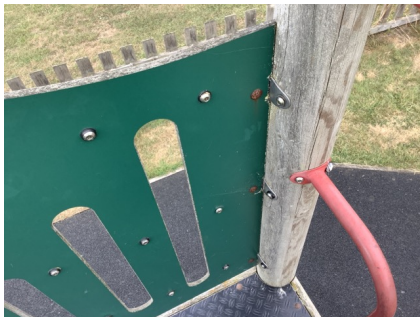
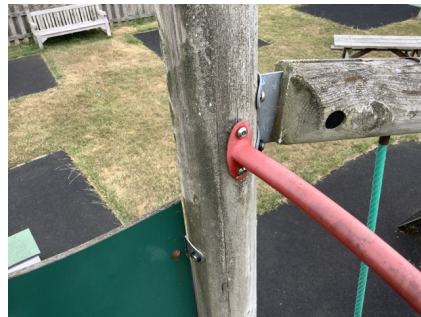
Fixtures loose or missing.

Barrier and guard rail fixings throughout - secure.

Tighten.

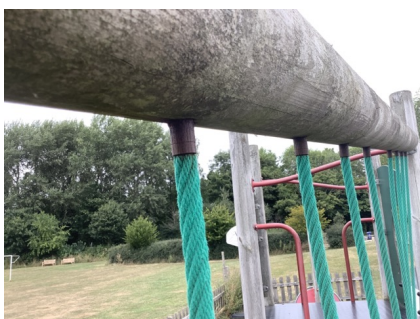
Fittings are rusty.

The rope connectors have known to snap when corroded - refer to the manufacturer for comment.

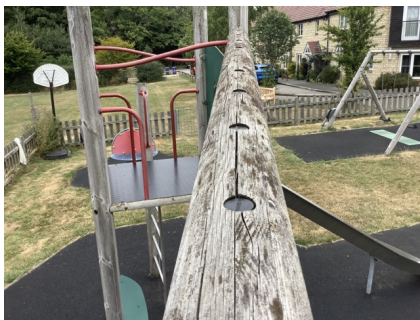
There are natural splits / shakes in the timbers.

Monitor for decay forming within the shakes on the crossbar.

Shakes vary. Monitor and consult manufacturer if dimensions exceed 8 mm at sections used to grip / grasp.

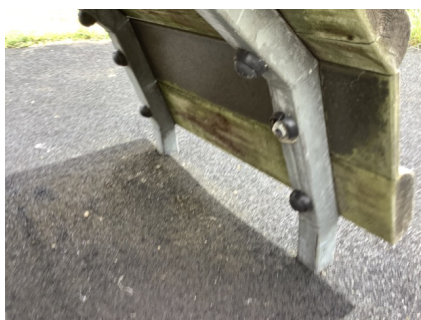
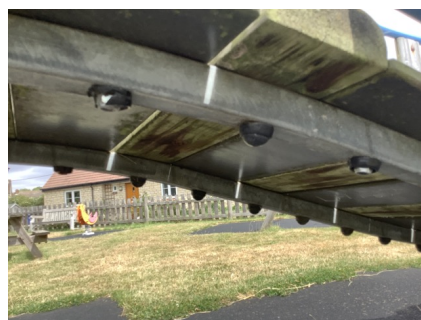
Cap missing.

Replace.

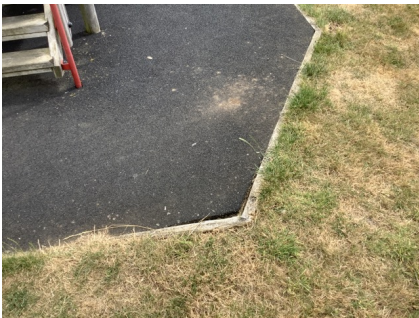
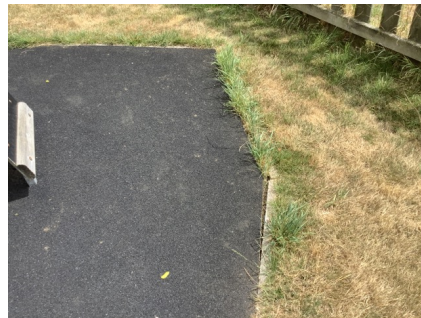
Shrinkage / separation of the surface. This may give a trip hazard.

Allow grass to establish in the gap, as this may prevent the wet pour from shrinking further.

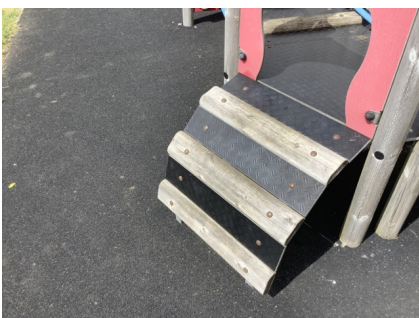
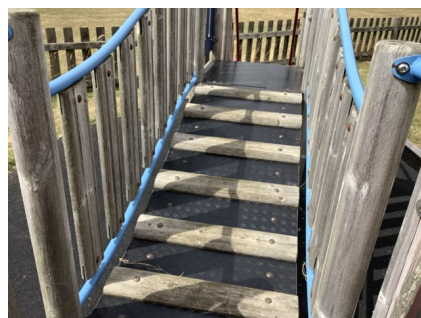
Fixtures loose or missing.

Ramp and bridge slats loose - secure.

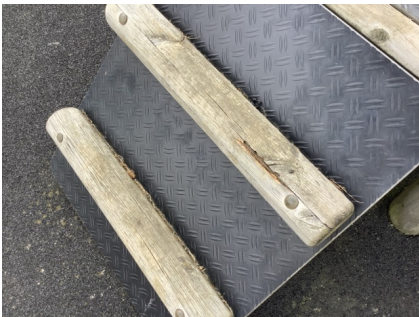
Timber is decayed.

Sand back rough edges and monitor for any further deterioration.

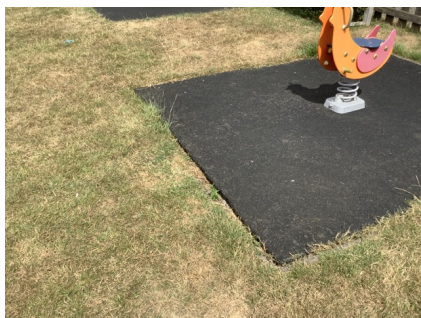
Shrinkage / separation of the surface. This may give a trip hazard.

Re-glue and fill gaps and joints as necessary.

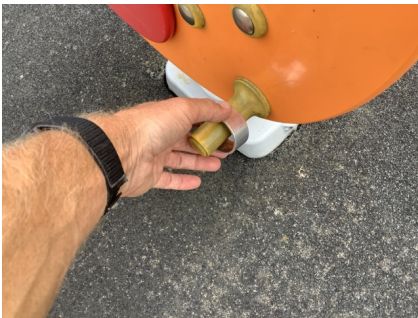
Protruding handles / foot rests.

The unit was installed prior to the publication of the current standards. There is no requirement to make retrospective changes.

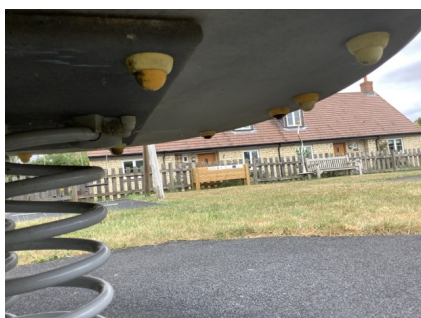
Cap missing.

Replace.

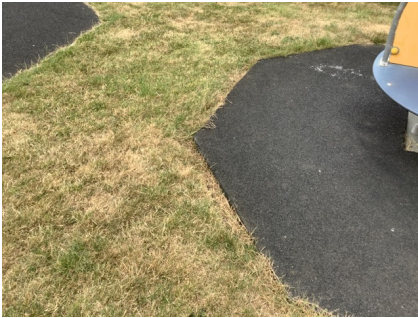
Shrinkage / separation of the surface. This may give a trip hazard.

Re-glue and fill gaps and joints as necessary.

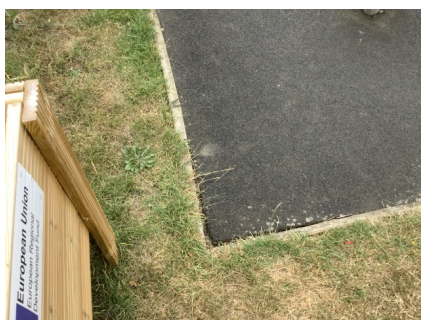
Shrinkage / separation of the surface. This may give a trip hazard.

Re-glue and fill gaps and joints as necessary.

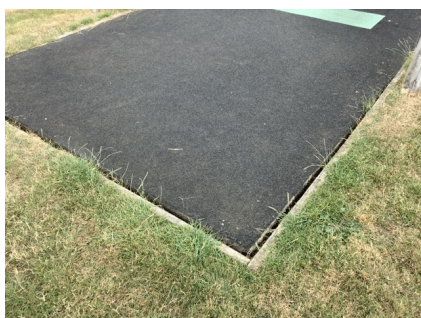
Shrinkage / separation of the surface. This may give a trip hazard.

Re-glue and fill gaps and joints as necessary.

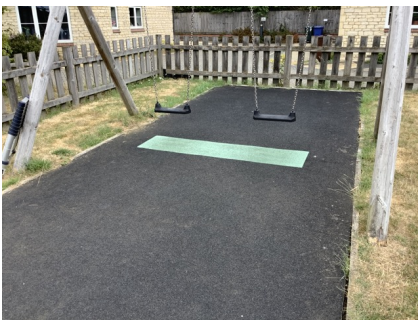
Timber is decayed.

Legs x 4 rotting below ground level - the inspector recommends replacing the two front legs and monitor the others closely for any further deterioration.

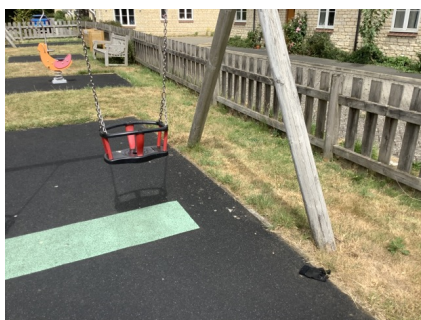
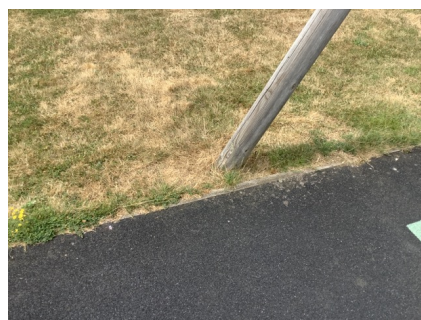
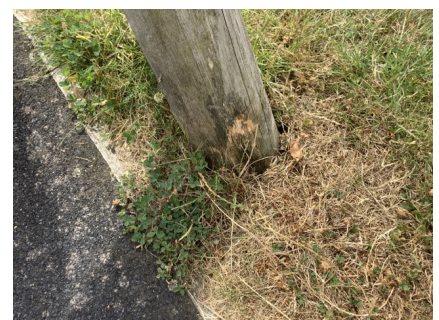
Timber is decayed.

Support posts x 3 rotting - replace and 1 x strummer damage - monitor.

Replace affected parts.

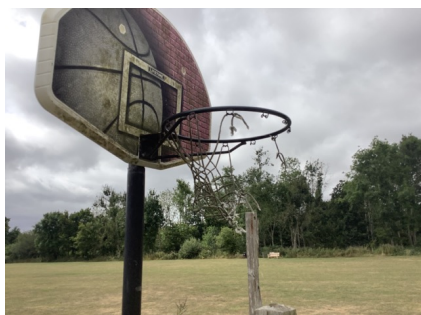
Item is damaged.

Replace damaged net.

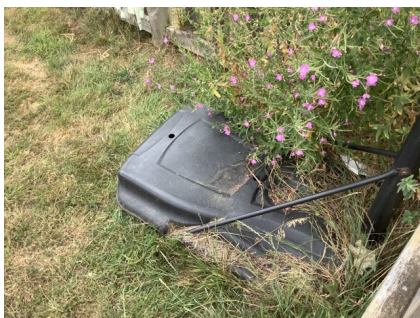
The base is not weighted and can easily topple - secure.

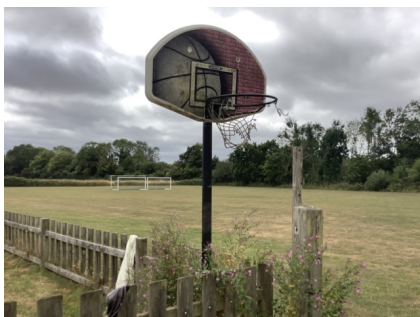
A warning notice should be fitted to all sports related equipment with the words "do not climb on the framework or nets", "do not hang on the ring" (if provided) and "do not wear rings or other jewellery as these can get caught and cause injury".

Fit warning notice.
