Safety Inspection Report

Annual Inspection

Church Lane

19 July 2023

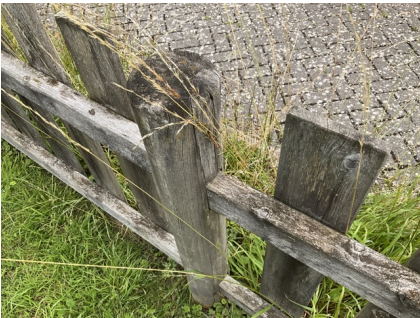
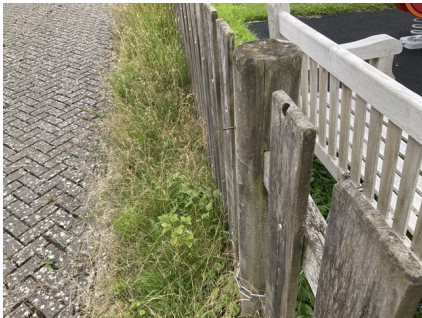
Description
Hard or sharp projections.
Tasks
Remove hard, pointed and sharp projections.
Note
Remove protruding nails.

Risk level:
Low
Risk score:
7

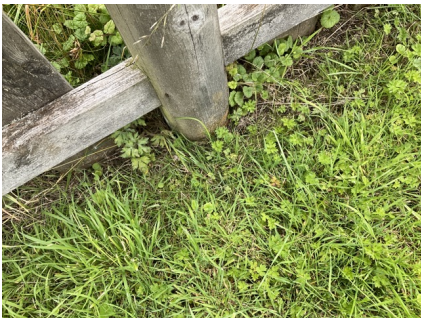
Strimmer damage to supports is likely to accelerate timber rot.

Low

4

Prevent further damage.

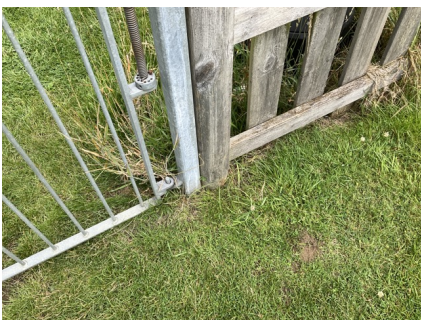
Timber is decayed.

A number of fence posts are softening at ground level. Monitor.

Low

5

Check on a routine basis.

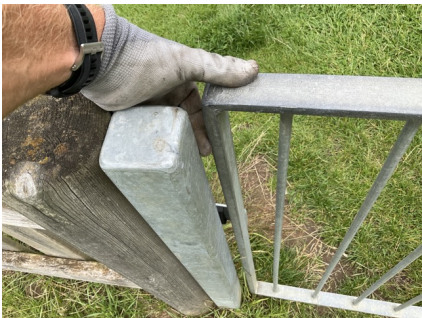
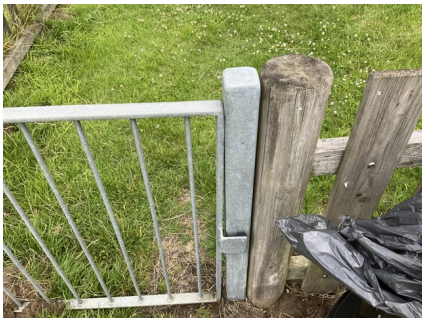
There is a crushing or shearing point on the side of the gate. Where the gaps reduce to less than 12 mm these have been known to cause serious, permanent injury to children, especially on the hinge side where the leverage forces are significant.

Adjust gate / posts / fit new rubber buffer to ensure a spacing of at least 12 mm throughout the range of the gate to remove the entrapment. The 12 mm gap also should apply on the hinge side of the gate.

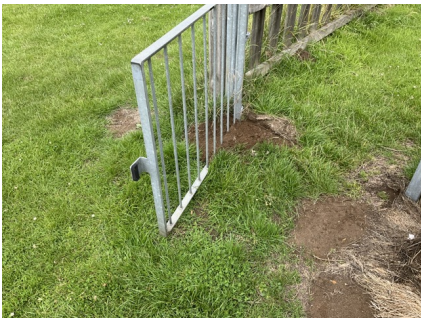
Gate is sticking on the ground.

Low

6

Adjust.

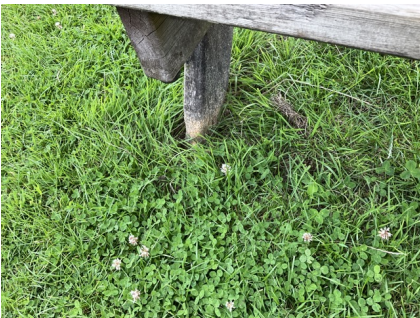
Strimmer damage to supports is likely to accelerate timber rot.

Risk level:
 Low

Risk score:
 4

Prevent further damage.

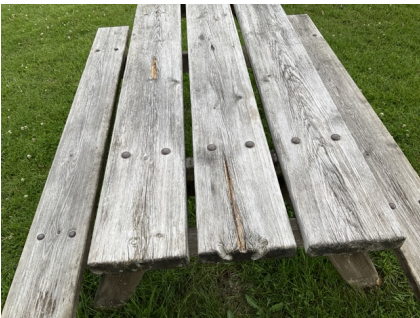
Timber is decayed.

Risk level:
 Low

Risk score:
 5

Check on a routine basis.

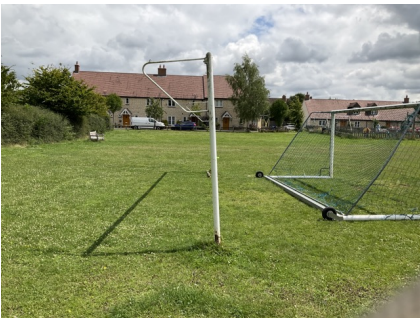
Loose in ground.

Low

5

Reset.

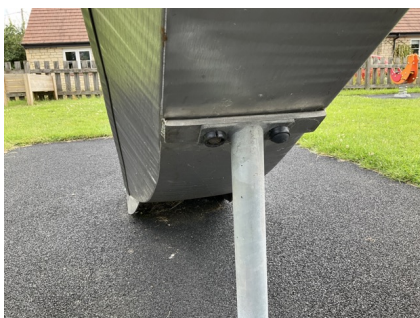
Cap missing.

Replace.

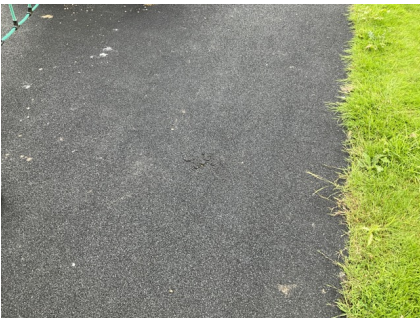
The wet pour surface is cracking.

Risk level:
 Low

Risk score:
 6

Repair.

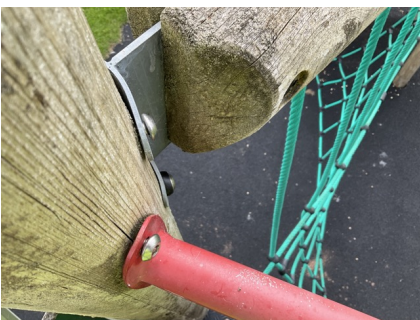
Fixtures loose or missing.

Barrier and guard rail fixings throughout. Secure.

Risk level:
 Low

Risk score:
 5

Tighten.

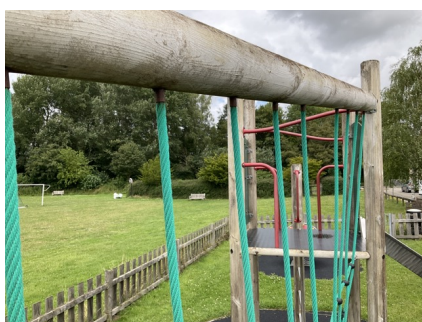
Fittings are rusty.

The rope connectors have known to snap when corroded. Refer to the manufacturer for comment.

Medium

9

Read the notes for further action.

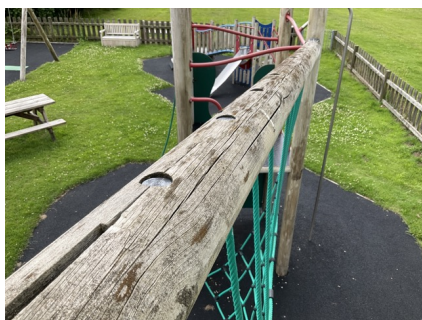
There are natural splits / shakes in the timbers.

Monitor for decay forming within the shakes on the crossbar.

Low

6

Shakes vary. Monitor and consult manufacturer if dimensions exceed 8 mm at sections used to grip / grasp.

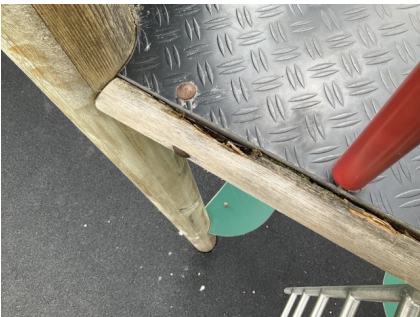
Timber is decayed.

Low

6

Sand back rough edges and monitor for any further deterioration.

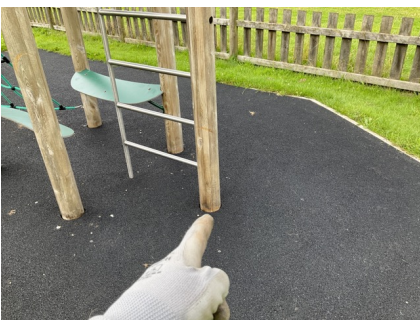
Timber is decayed.

Low

5

Check on a routine basis.

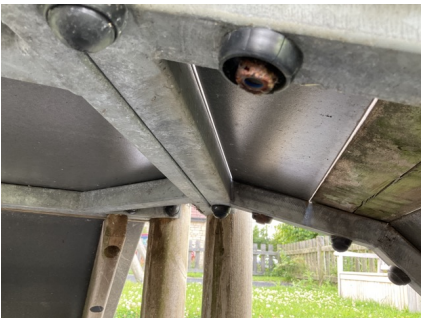
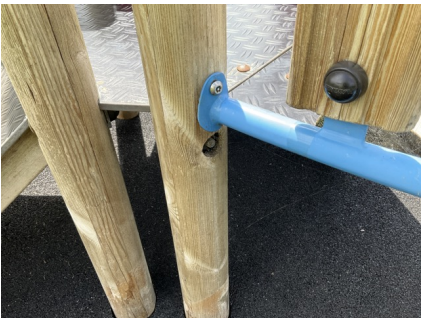
Cap missing.

Very low

3

Replace.

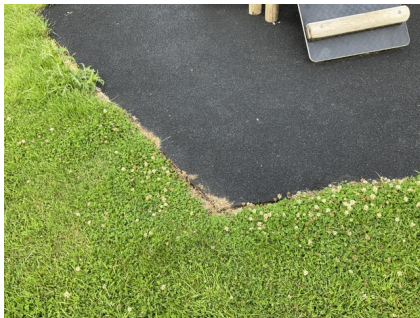
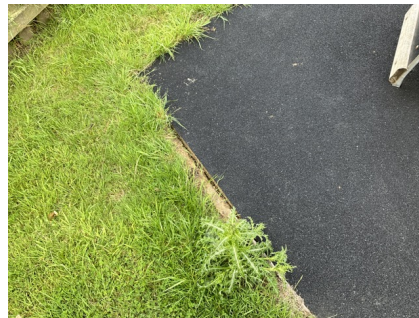
Shrinkage / separation of the surface. This may give a trip hazard.

Low

5

Allow grass to establish in the gap, as this may prevent the wet pour from shrinking further.

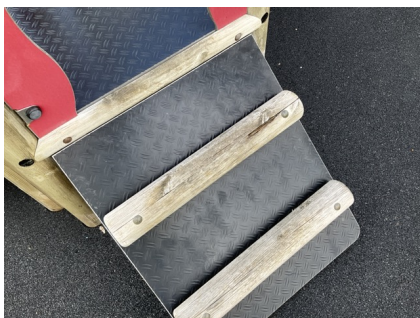
Timber is decayed.

Low

5

Sand back rough edges and monitor for any further deterioration.

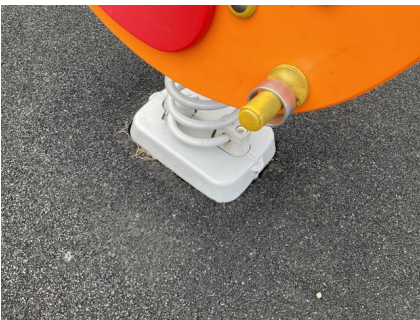
Protruding handles / foot rests.

Very low

3

The unit was installed prior to the publication of the current standards. There is no requirement to make retrospective changes.

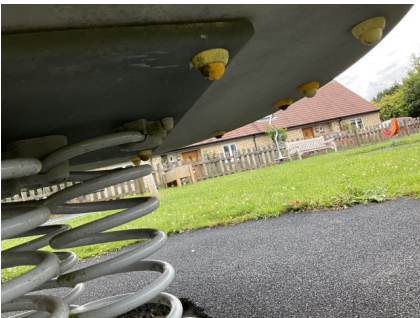
Cap missing.

Low

5

Replace.

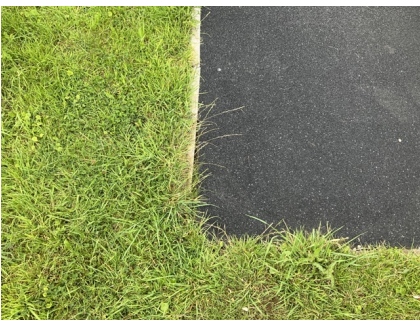
Shrinkage / separation of the surface. This may give a trip hazard.

Low

5

Re-glue and fill gaps and joints as necessary.

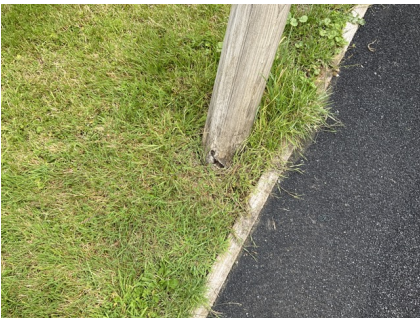
Timber is decayed.

Legs x 4 rotting below ground level. The inspector recommends excavating down to foundation level to investigate the extent of decay.

Medium

12

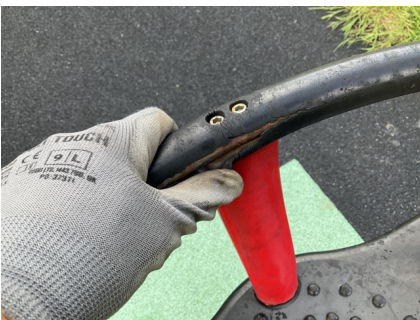
Corrosion in cradle seat top frame could lead to sudden failure of the seat.

Medium

12

Investigate and replace as necessary.

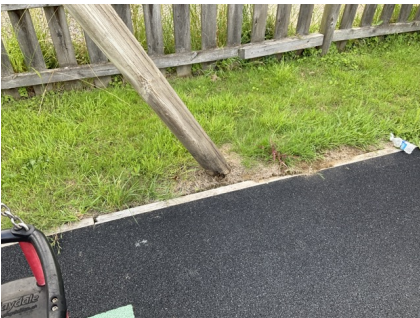
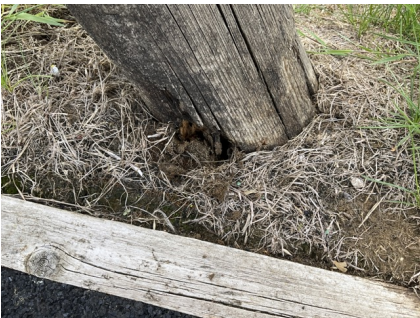
Timber is decayed.

Support posts x 3 rotting. Replace and 1 x strimmer damage. Excavate around the remaining posts to inspect the extent of decay.

High

16

Replace affected parts.
