Safety Inspection Report

Annual Inspection

Church Lane

19 July 2023

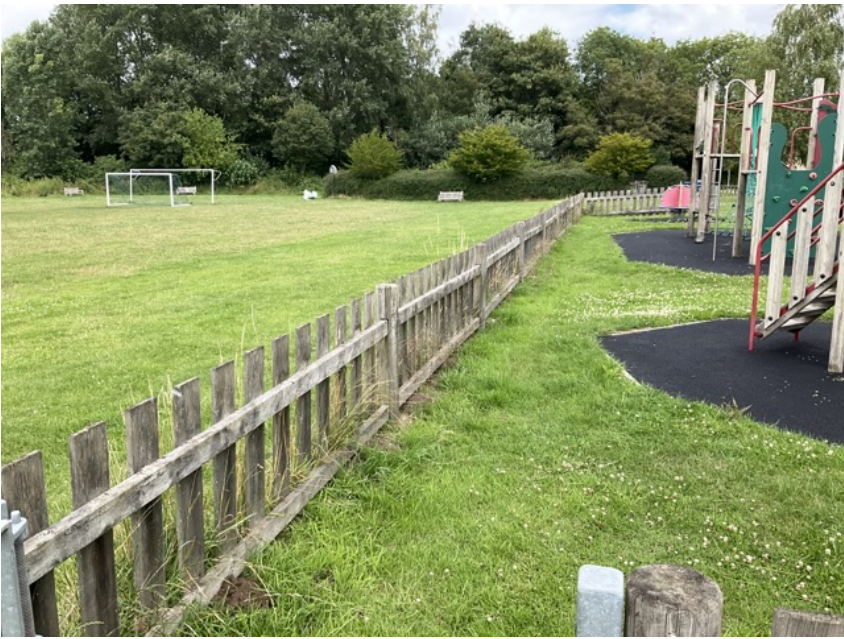
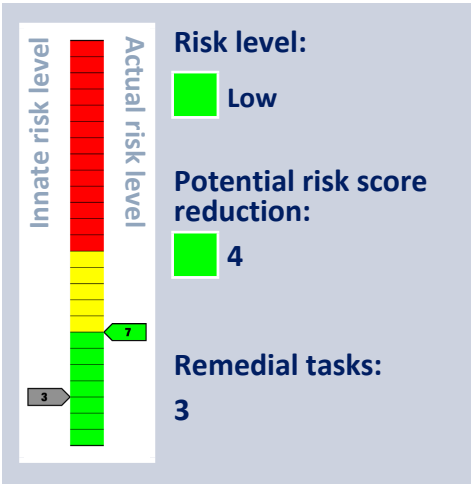
Fencing

Description
Hard or sharp projections.
Tasks
Remove hard, pointed and sharp projections.
Note
Remove protruding nails.

Strimmer damage to supports is likely to accelerate timber rot.

Timber is decayed.

Prevent further damage.

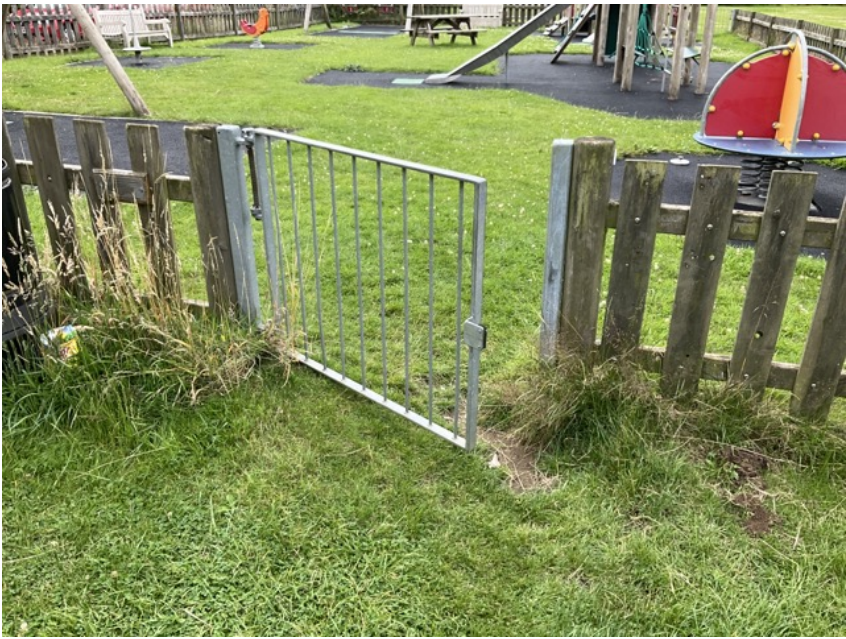
Gate

There is a crushing or shearing point on the side of the gate. Where the gaps reduce to less than 12 mm these have been known to cause serious, permanent injury to children, especially on the hinge side where the leverage forces are significant.

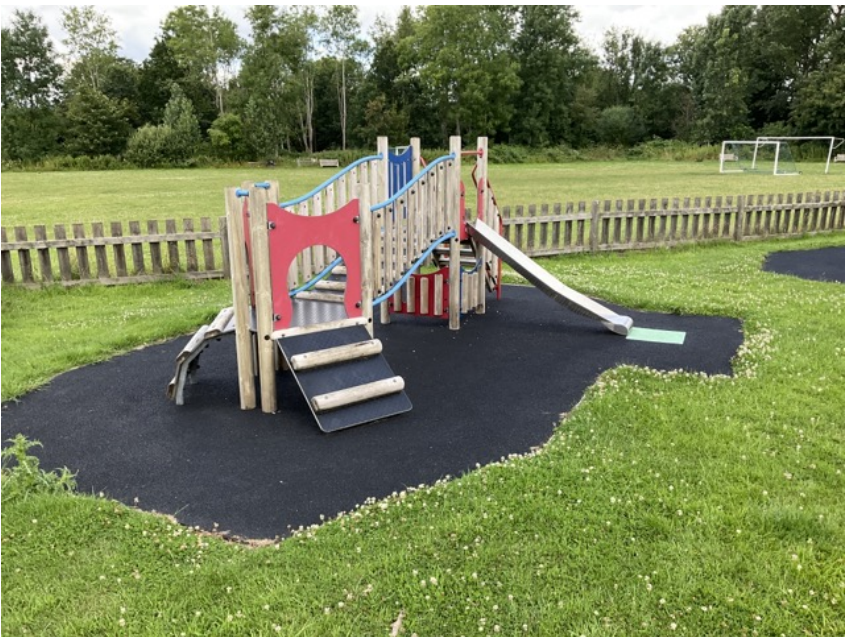
Multiplay - Toddler

Cap missing.

Shrinkage / separation of the surface. This may give a trip hazard.

Timber is decayed.

Replace.

Sand back rough edges and monitor for any further deterioration.

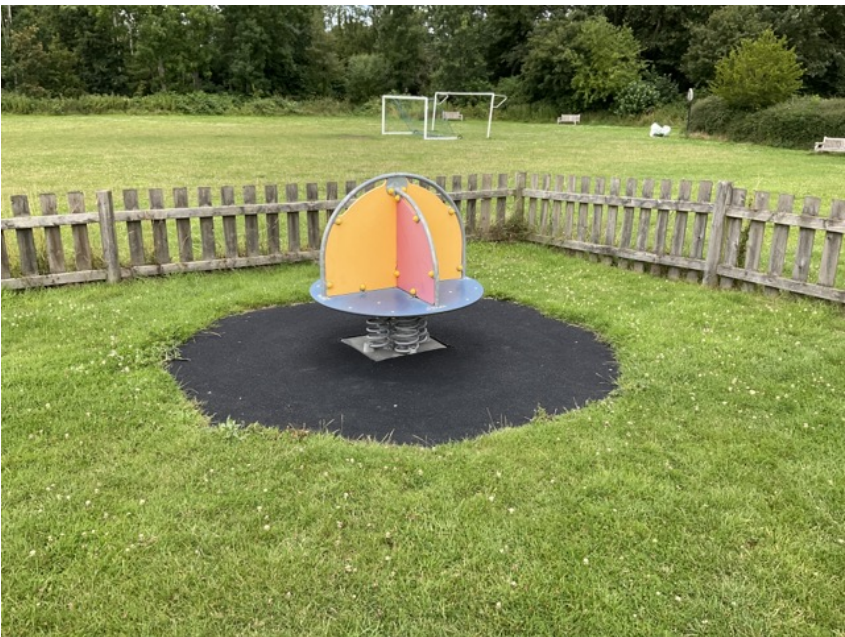
Rocker - Platform

Cap missing.

Replace.

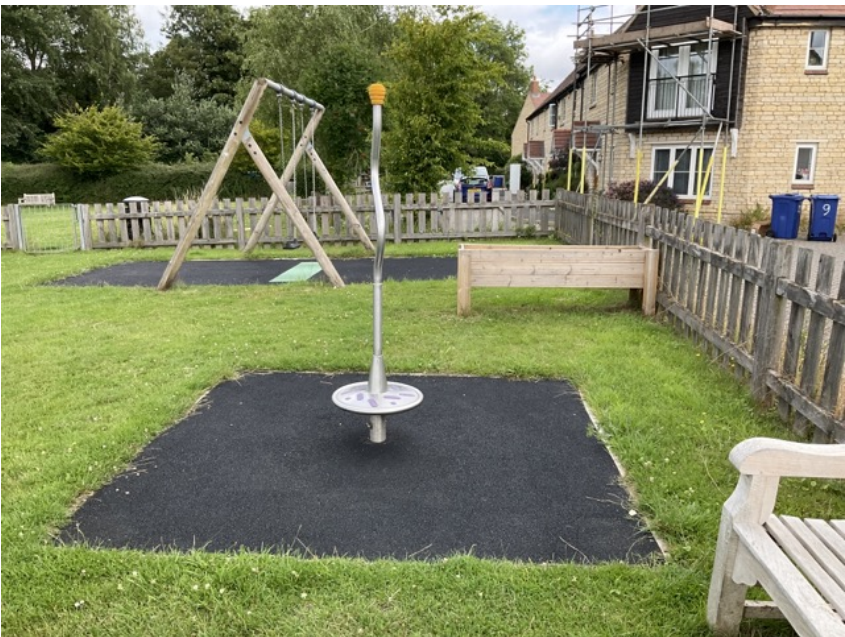
Rotator - Spica

Shrinkage / separation of the surface. This may give a trip hazard.

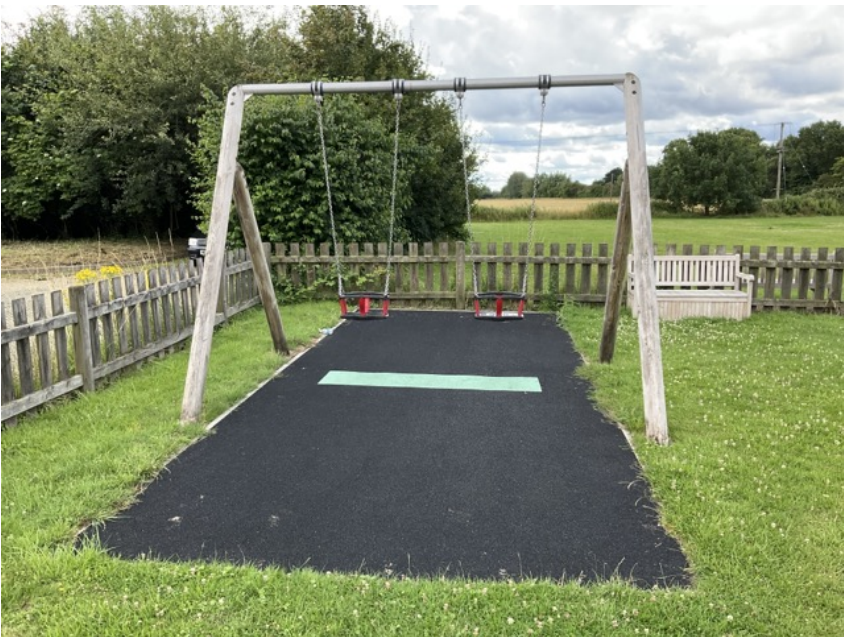
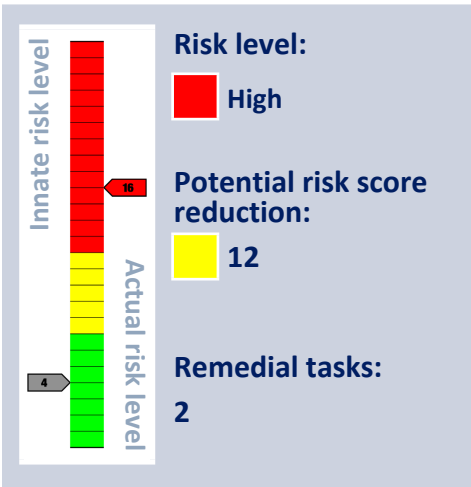
Swing - Toddler - 1 Bay 2 Seat

Corrosion in cradle seat top frame could lead to sudden failure of the seat.

Timber is decayed.

Support posts x 3 rotting. Replace and 1 x strimmer damage. Excavate around the remaining posts to inspect the extent of decay.

Investigate and replace as necessary.

Replace affected parts.

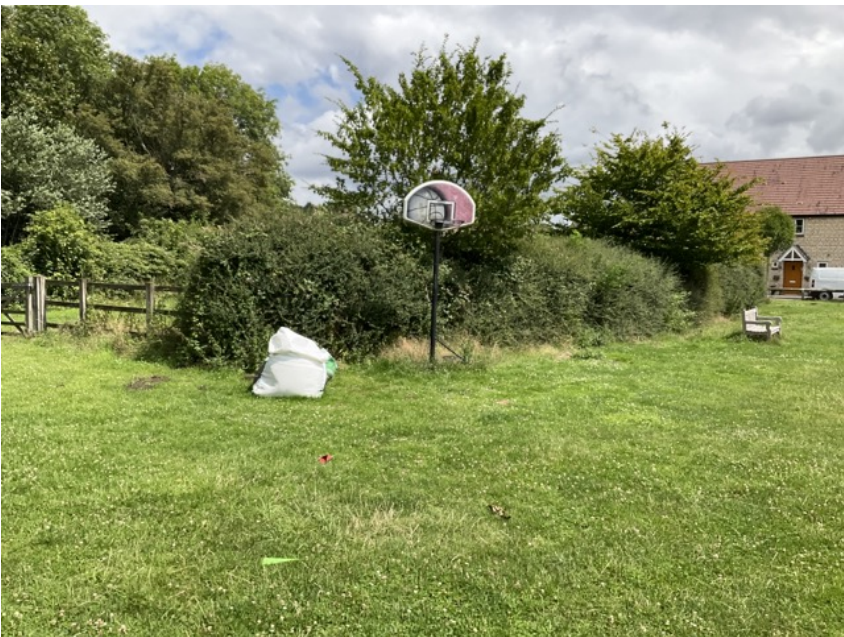
Basketball Post

A warning notice should be fitted to all sports related equipment with the words "do not climb on the framework or nets", "do not hang on the ring" (if provided) and "do not wear rings or other jewellery as these can get caught and cause injury".
